# Cases of Bridge Damages caused by Floods and some Countermeasures

March 8, 2018  
Dr. NAKAO Tadahiko  
JIP

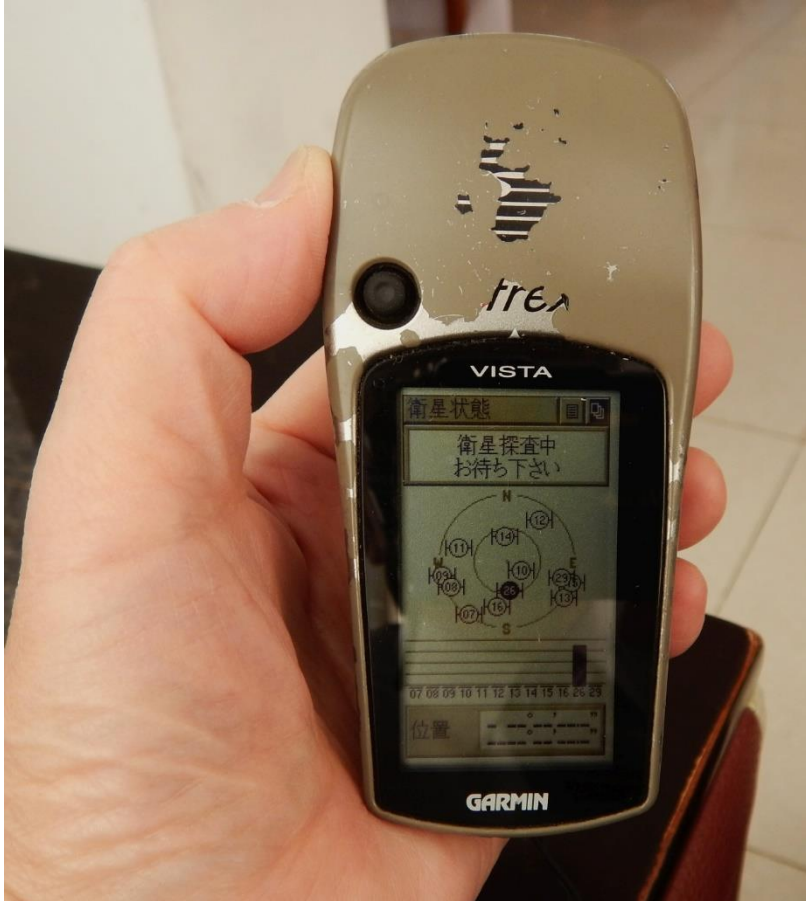
Garmin's E-trex VISTA

- Pocket GPS is good enough to get longitude and latitude.
- We can get more precise values through more sophisticated apparatus, but high precision values are not necessary at the planning stage.

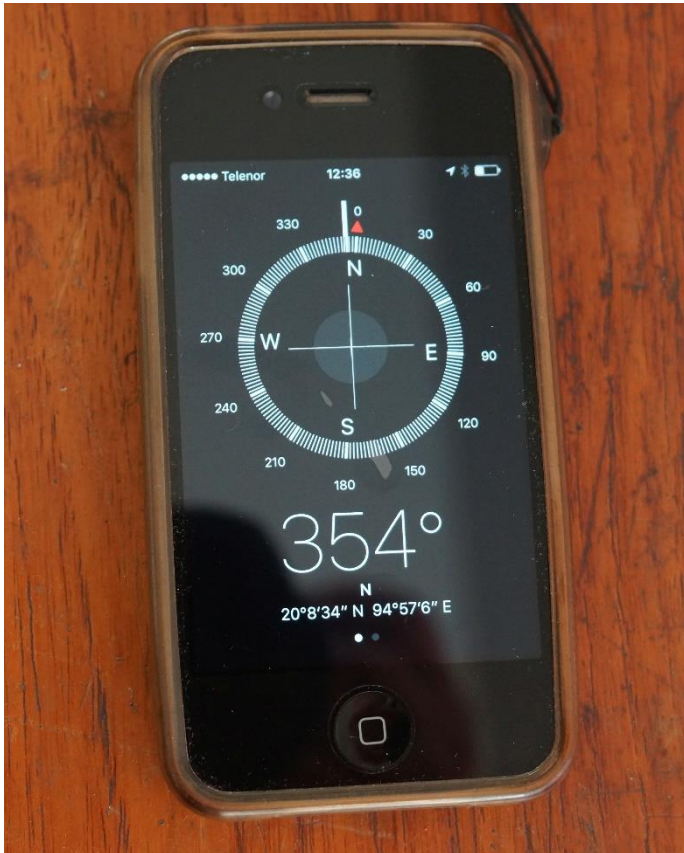
Free applications for Smart phones have been provided.

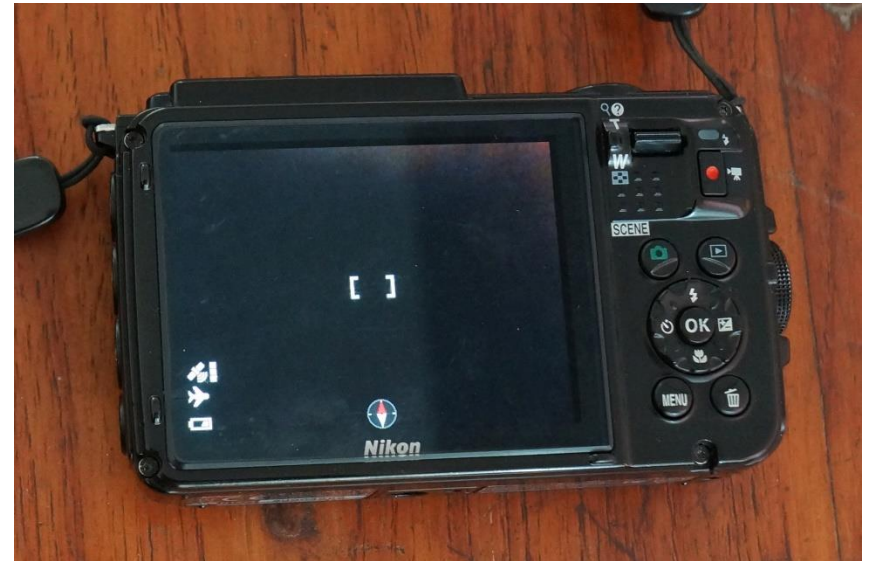
Some cameras have GPS functions.

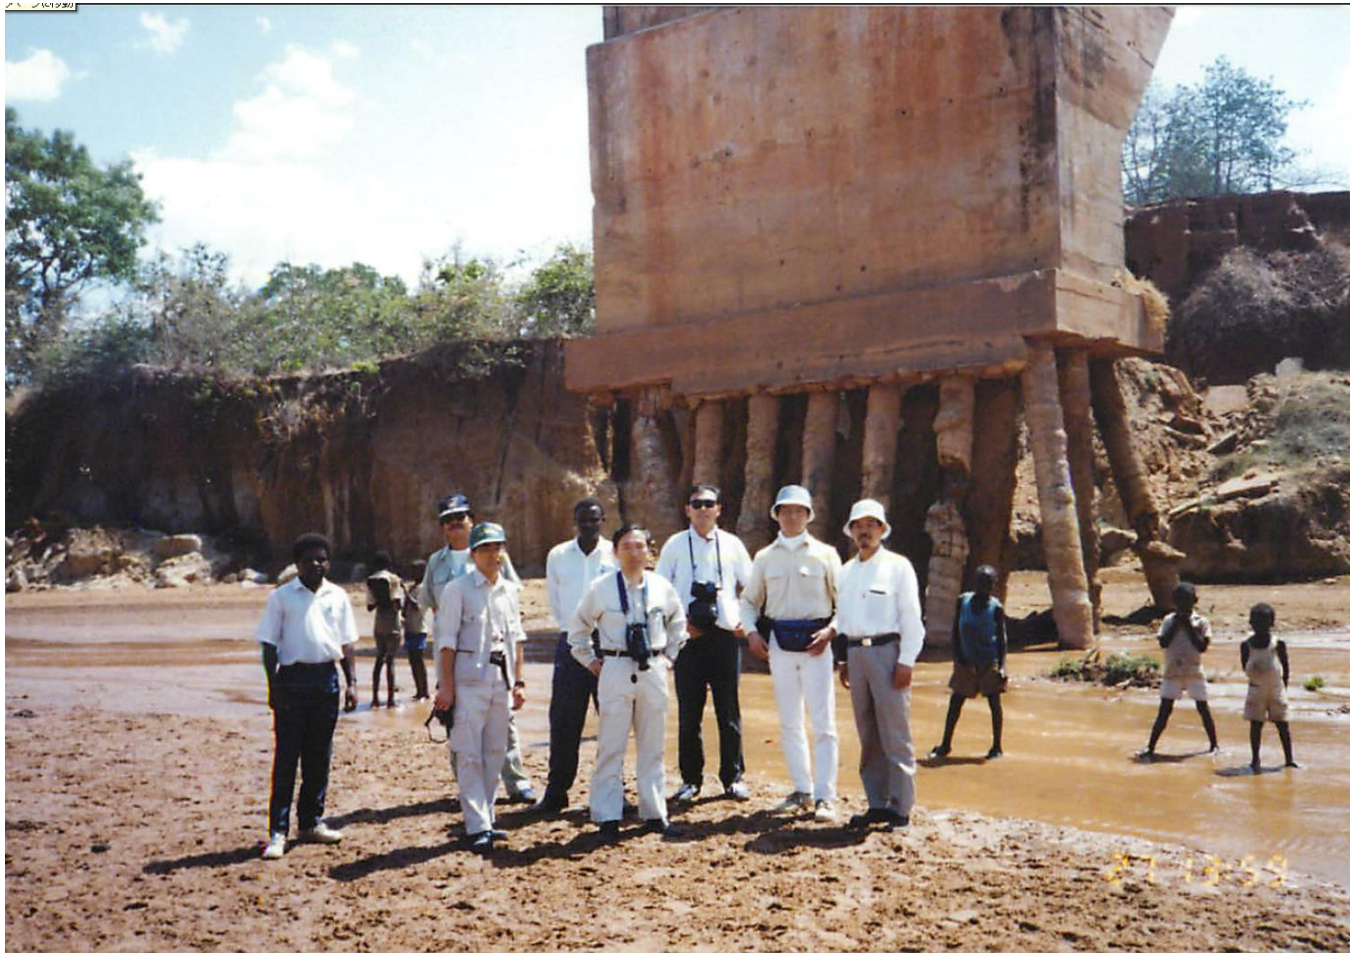
# Fast Degradation of the River Bed

Though Investigation of the Historical Floods is advisable, it is often difficult. <sup>5</sup>

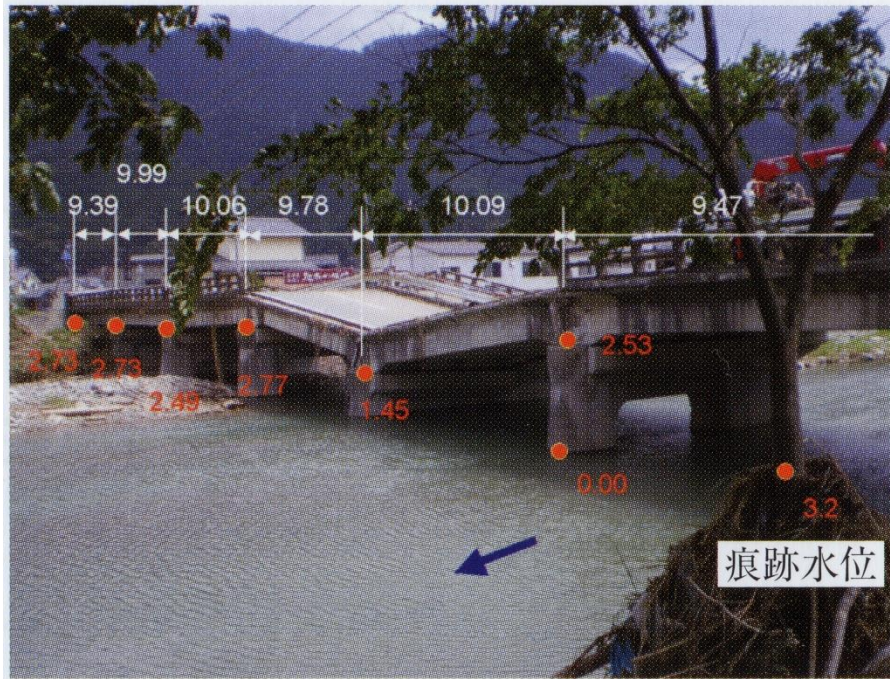
# Subsidence of a Pier (Japan)

After Flood

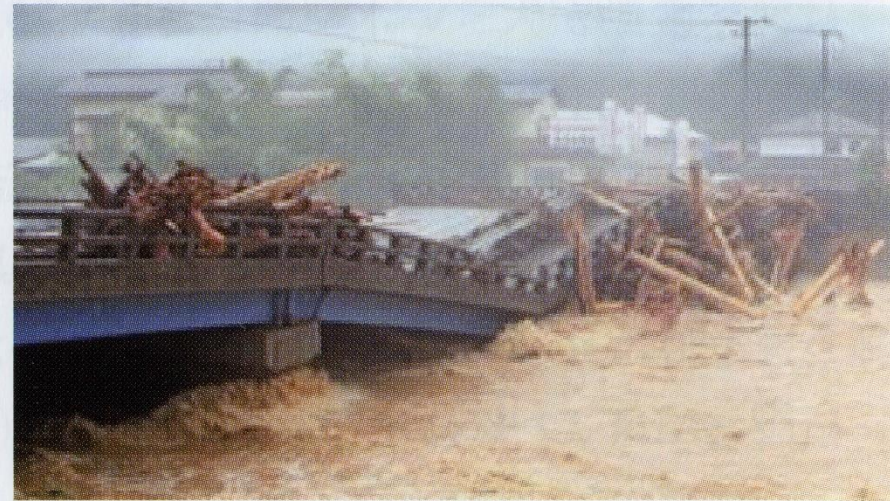
During Flood  
Floating Timbers are also remarkable.

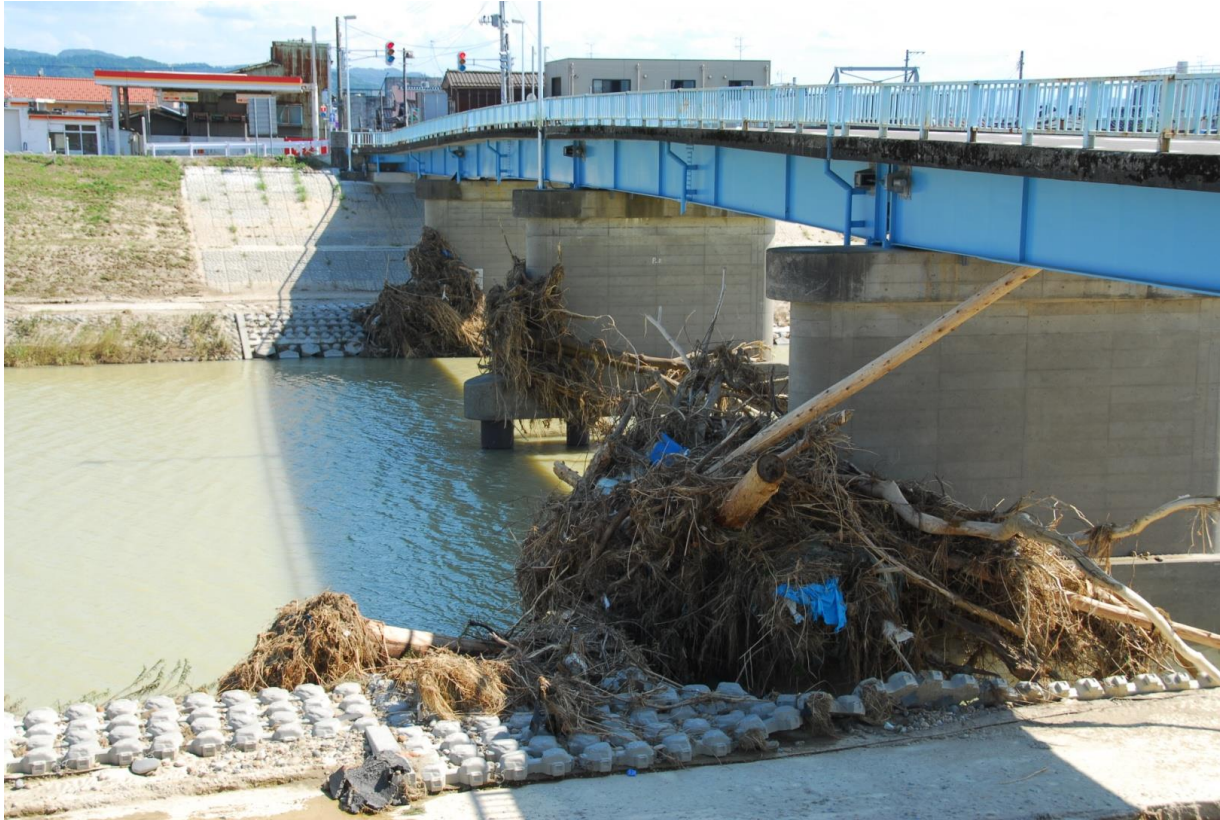
# Accumulation of Debris

Accumulation of debris will amplify the Lateral Force against Bridge Structures. Bridge slab should be rigidly fixed to the piers and to the foundation.

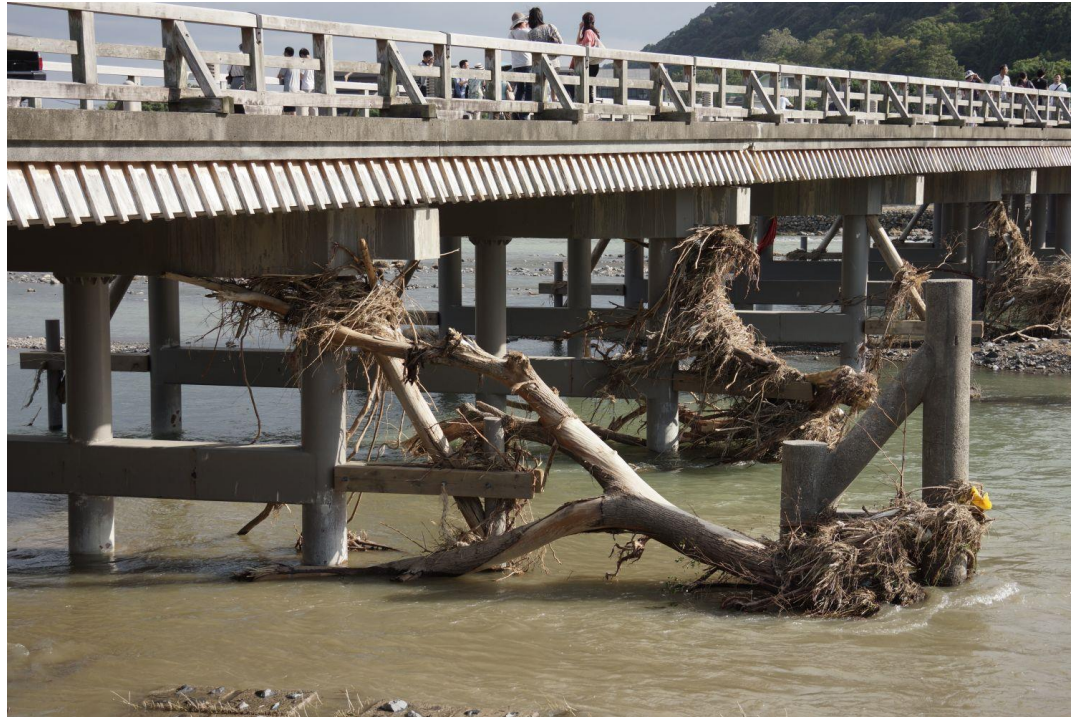
# Timbers floated down by a Flood

Some Preventive Measures had been taken, still timbers were accumulated. Slab and piers should have enough strength to resist against the shock force of the floating timbers.  
In case of JIP's submersible bridges, minimum of 50 cm is maintained.

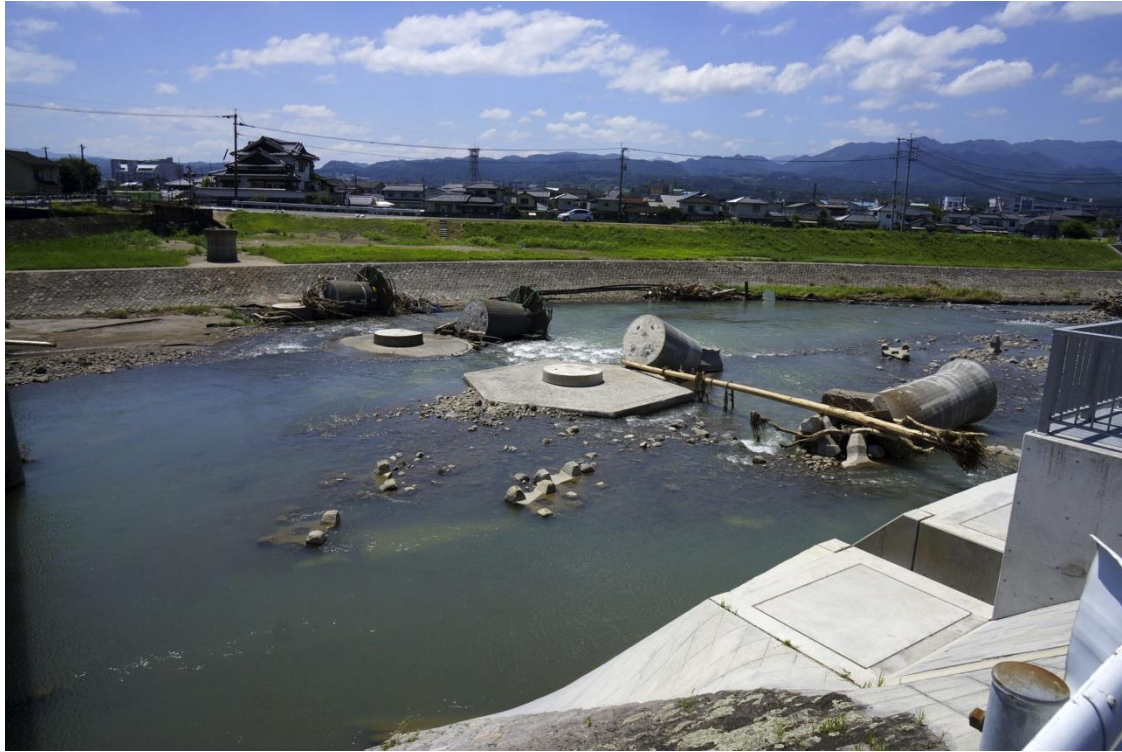
# Lateral Force against Piers

Piers should be Rigidly connected to the Foundation.  
This collapse was caused by the Accumulation of Timbers.  
In case of JIP's submersible bridges, Top slab, Piers, Footing, and Foundation Pile are rigidly connected with steel bars.

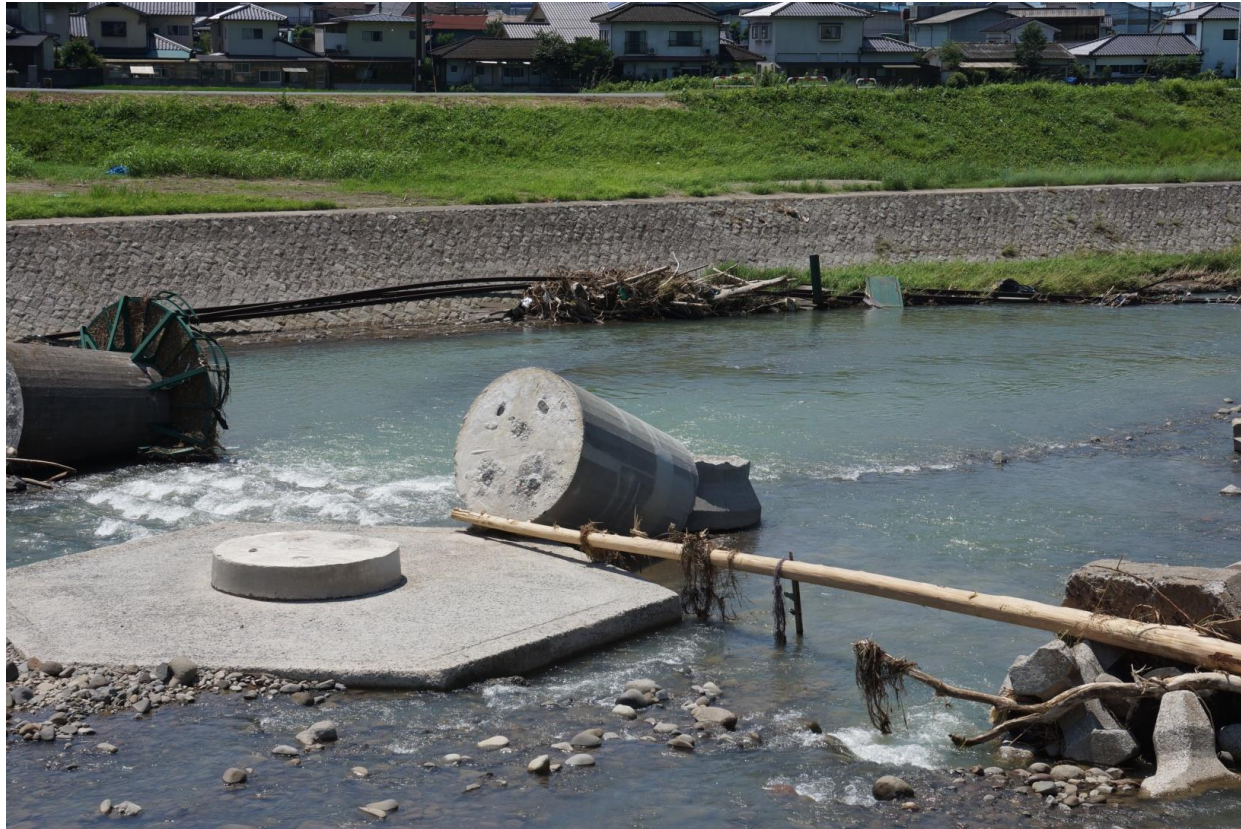
# Without Steel Bars!

Steel was so expensive in early Japan, that occasionally design of massive concrete structures was made without steel bars.

The timber in this photo has length of 12 m: longer than the bridge spans.

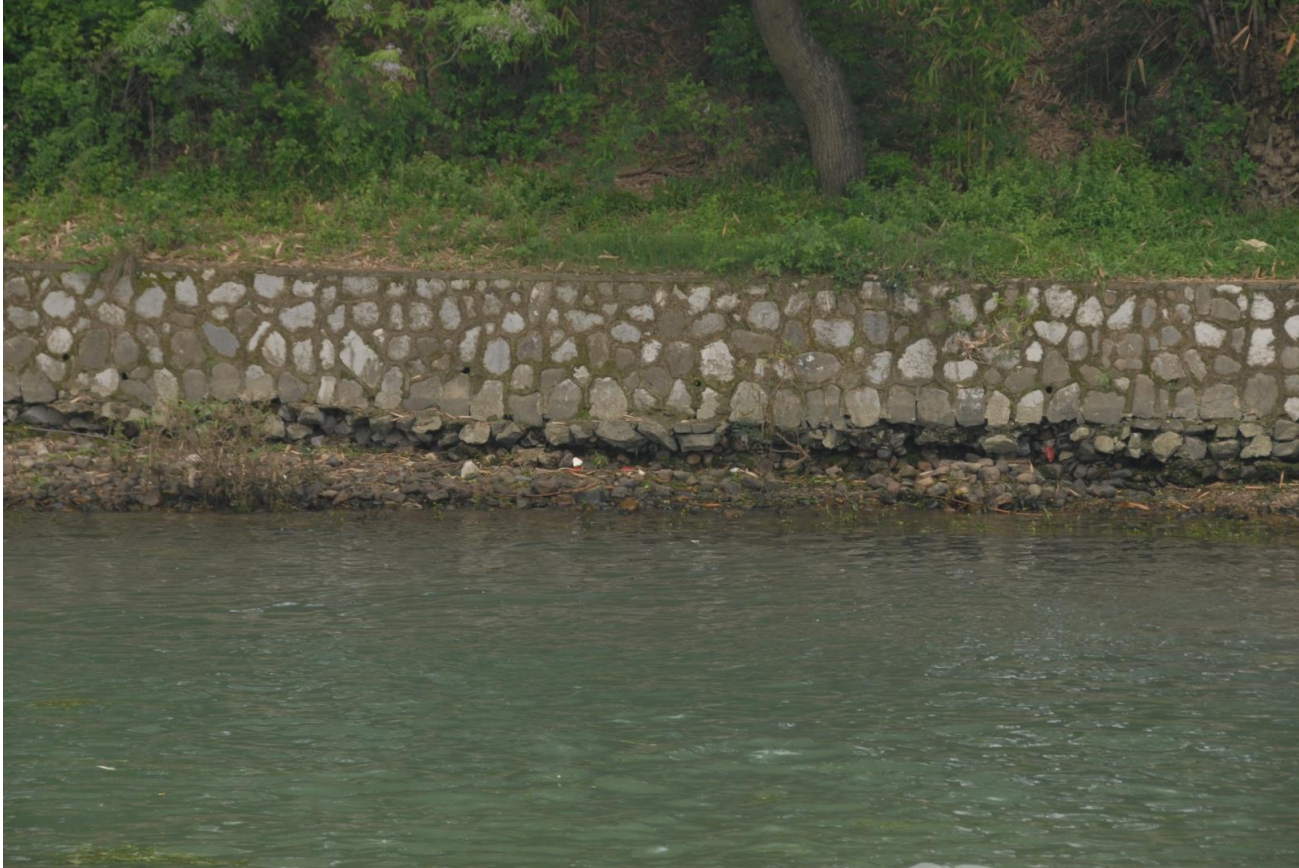
# Collapse of Revetment

This Failure was caused by River bed Degradation:  
Riverbed will change with Floods.

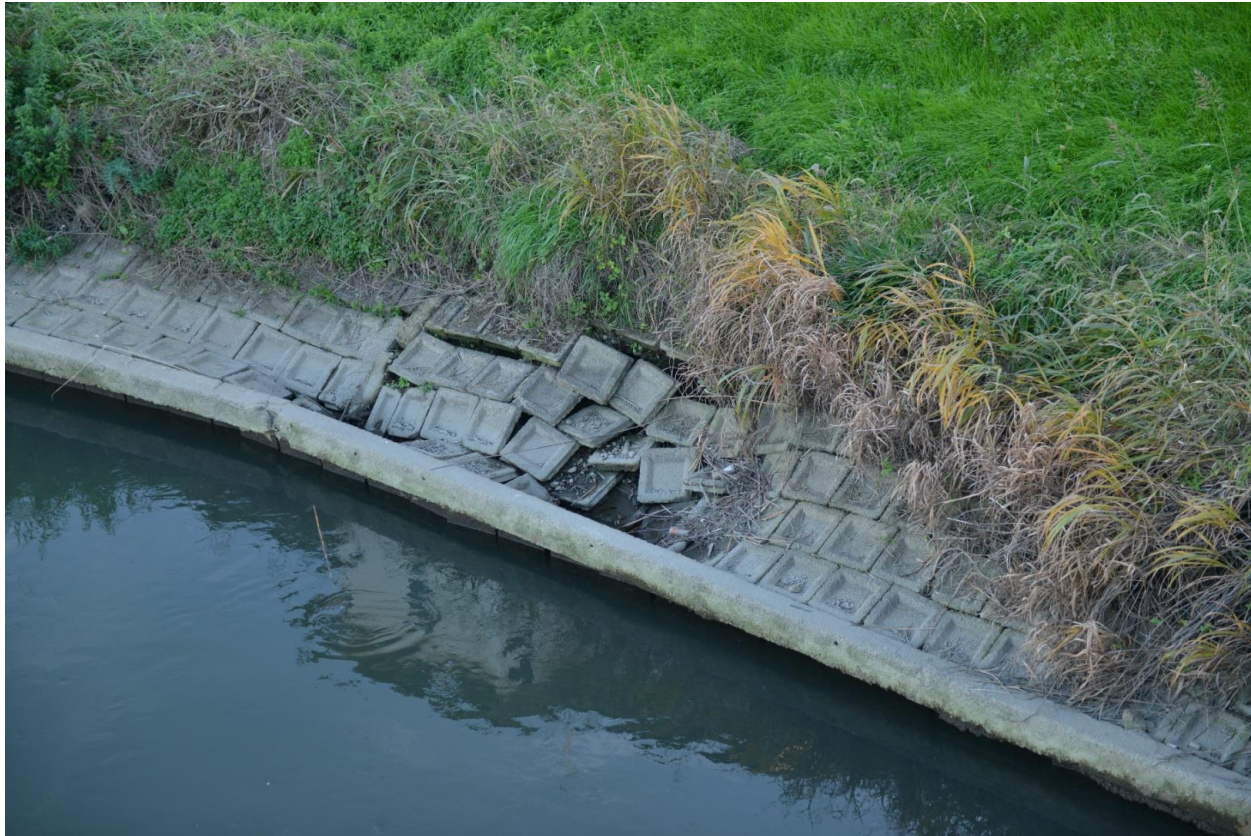
# Another example of Revetment Failure

Revetment with Rigid Structure is Vulnerable to Change of Boundary Conditions.

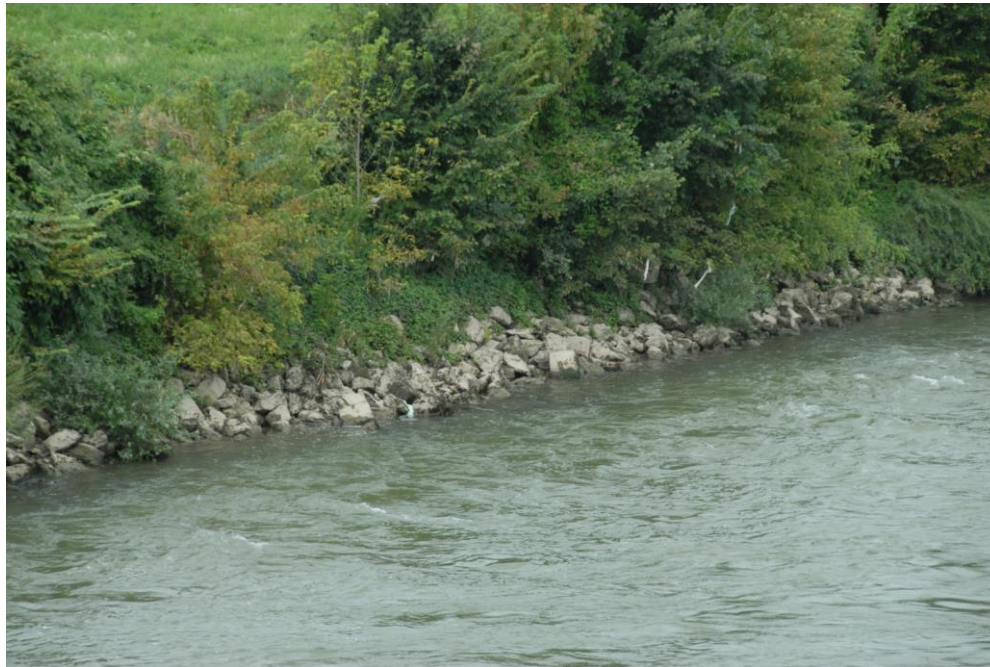
# Revetment of Stone-fill Type

Stones should be large enough to resist Dragging Force of Flood Water. This type of revetments will easily follow the river bed change, and still effective for bank protection.

Stone-fill type revetment will not harm the riverine scenery so much.

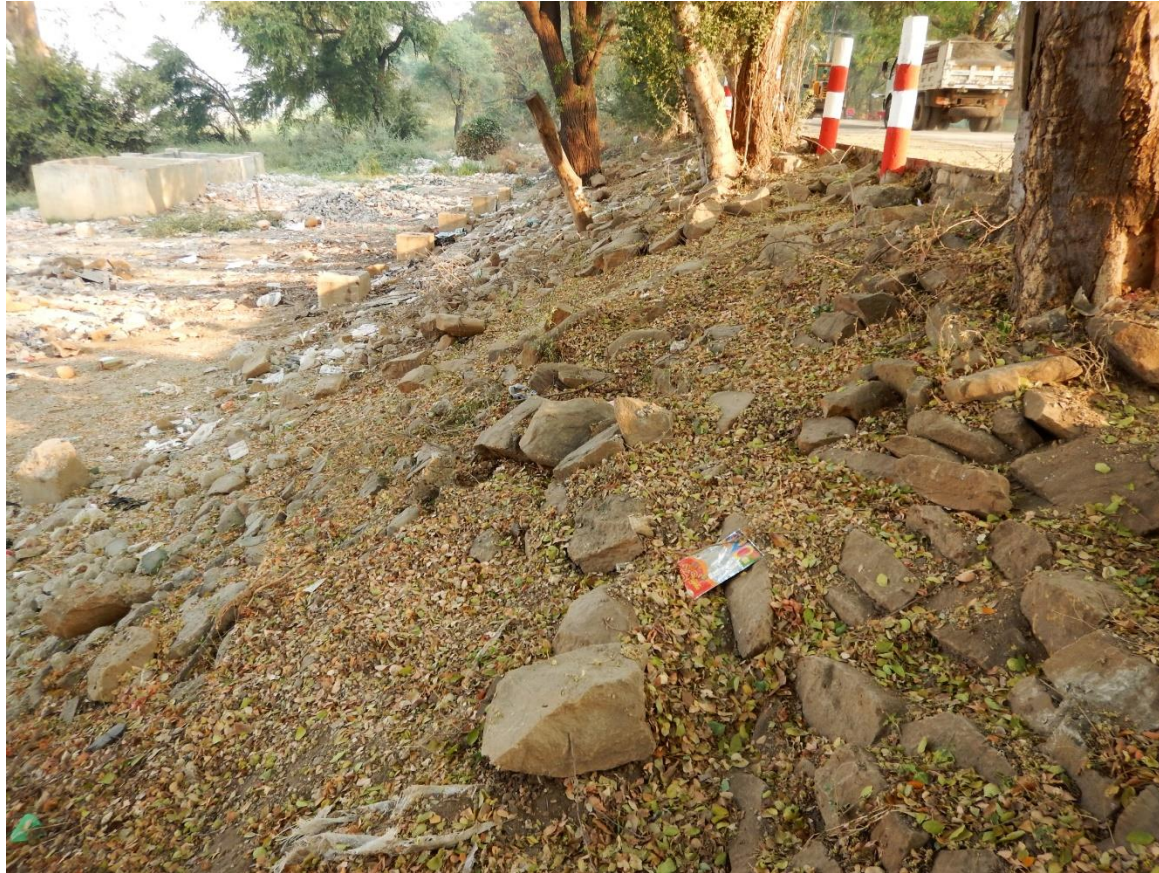
# Stone-fill Revetment of Myanmar

Along the Left Bank of the Ayeyarwadi at Magway  
20.134525 deg. N, 94.925002 deg. E

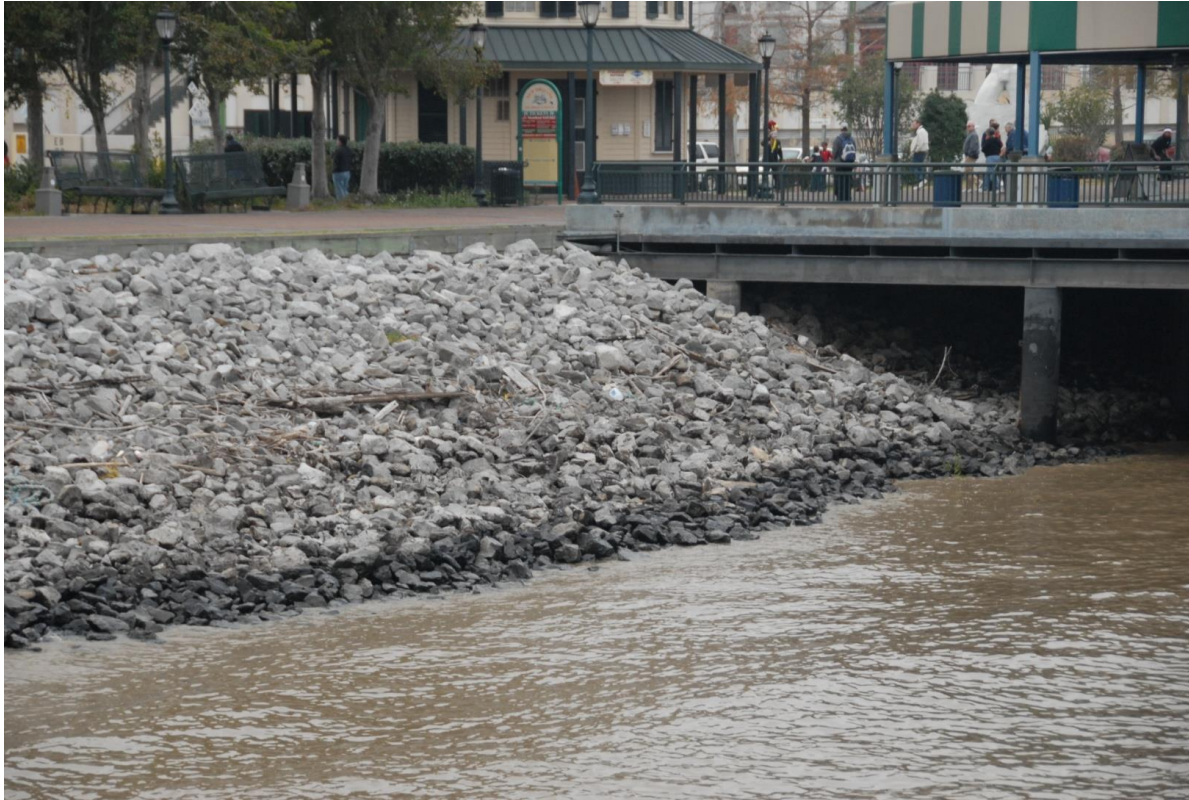
# Stone-fill Type of Revetment (USA)

This type of Revetment is widely used: On the Left Bank of the Mississippi.
